MONTCLAIR PROPERTY OWNERS ASSOCIATION DAM AND SPILLWAY TOWN HALL MEETING

Town Hall Meeting
1 March 2017
Montclair Dam and Spillways

Montclair Lake Rehab Design
Montclair Property Owners Association
Montclair, VA

CUT-BACK WALL
PRELIMINARY DETAILS

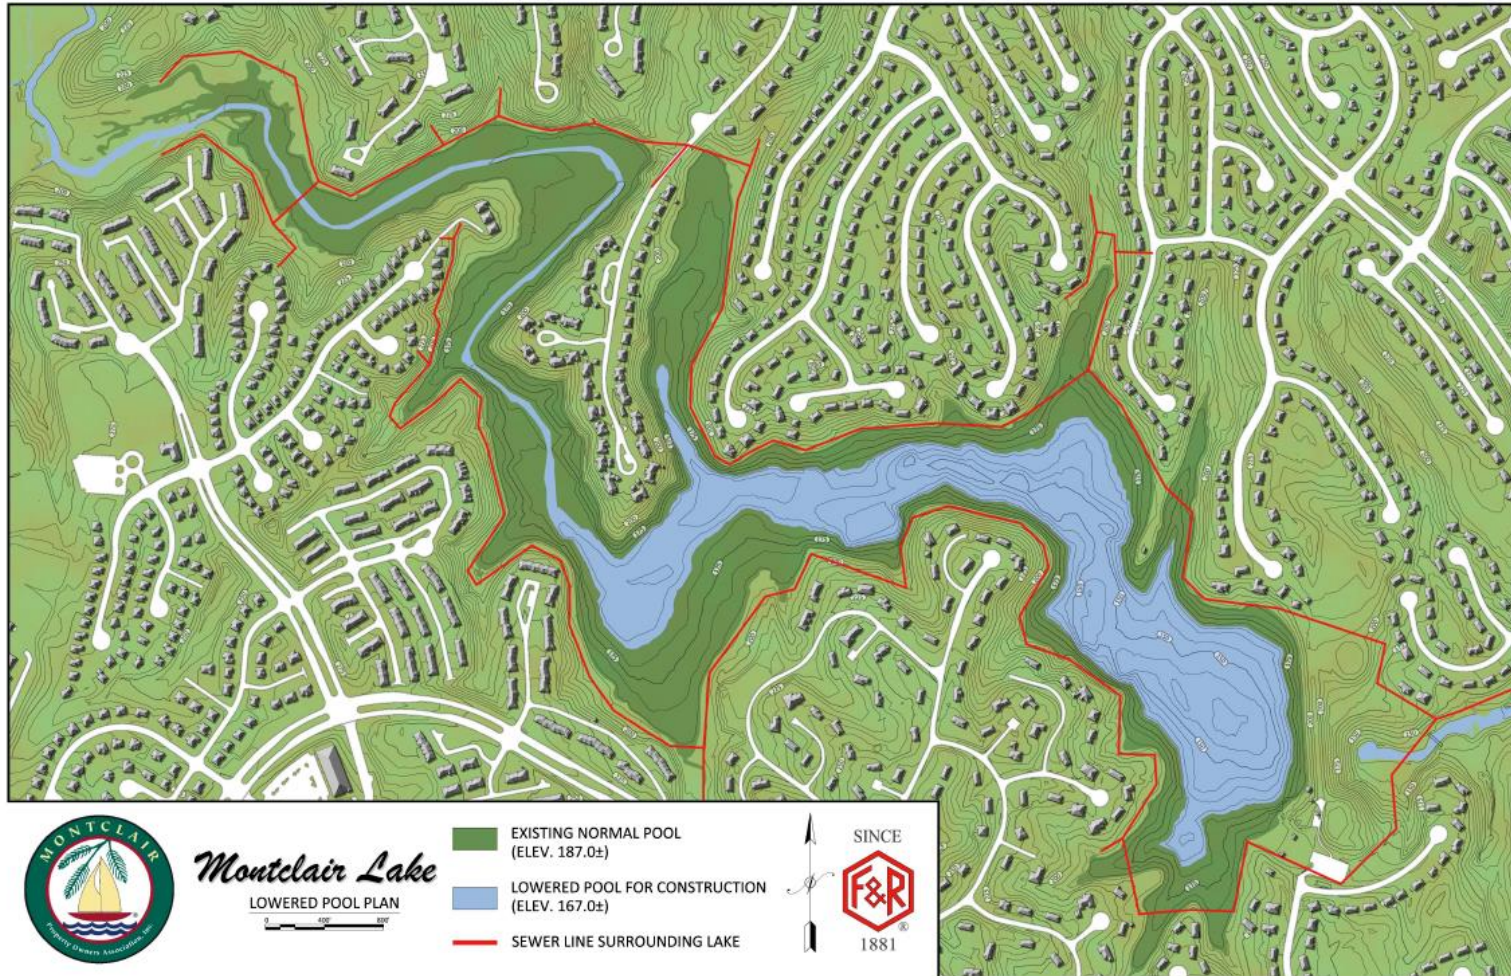
Lake Drawdown -20 feet

- Construction will require excavation to the competent bedrock
- Drawdown ensures water does not flow through the spillway during construction
- Construction needs a dry environment
- State must approve Design to include addressing all safety concerns
 - Construction Emergency Action Plan required
